CABLE MEDIAN BARRIER
FAILURE ANALYSIS AND REMEDIATION

by
Cody S. Stolle

A DISSERTATION

Major: Civil Engineering
Structural Engineering

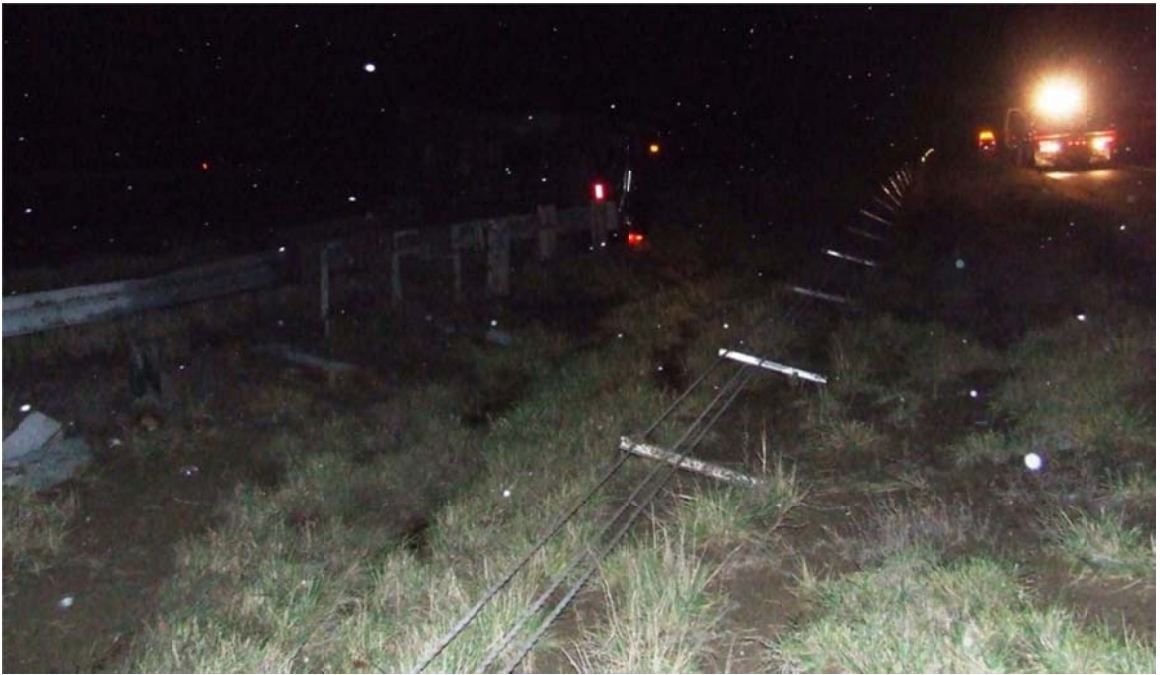
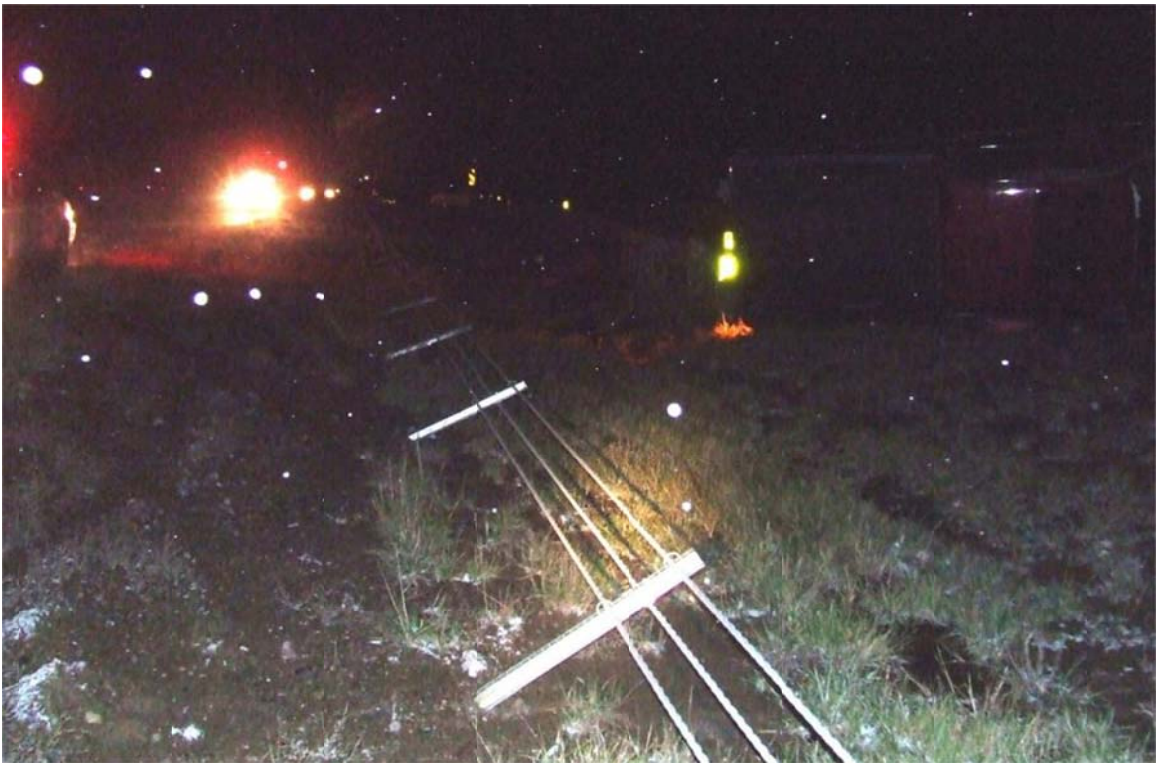
Figure 81. Penetration Crash Caused by Strong Cable-to-Post Attachment

An example of a crash in which the strong cable-to-post attachments contributed to vehicular penetration through the barrier is shown in Figures 81 and 82. In this crash, an impacting pickup lost control due to slick roadways and departed the roadway into the median. The CG trajectory angle was approximately 24 degrees, and the orientation angle of the vehicle at impact was approximately 110 deg. The vehicle impacted the cables and began to redirect. The first few impacted posts were pulled out of the ground as the pickup was redirecting, and the strength of the cable-to-post attachments retained the posts on the cables. Due to the high orientation angle at impact, the cables did not locally

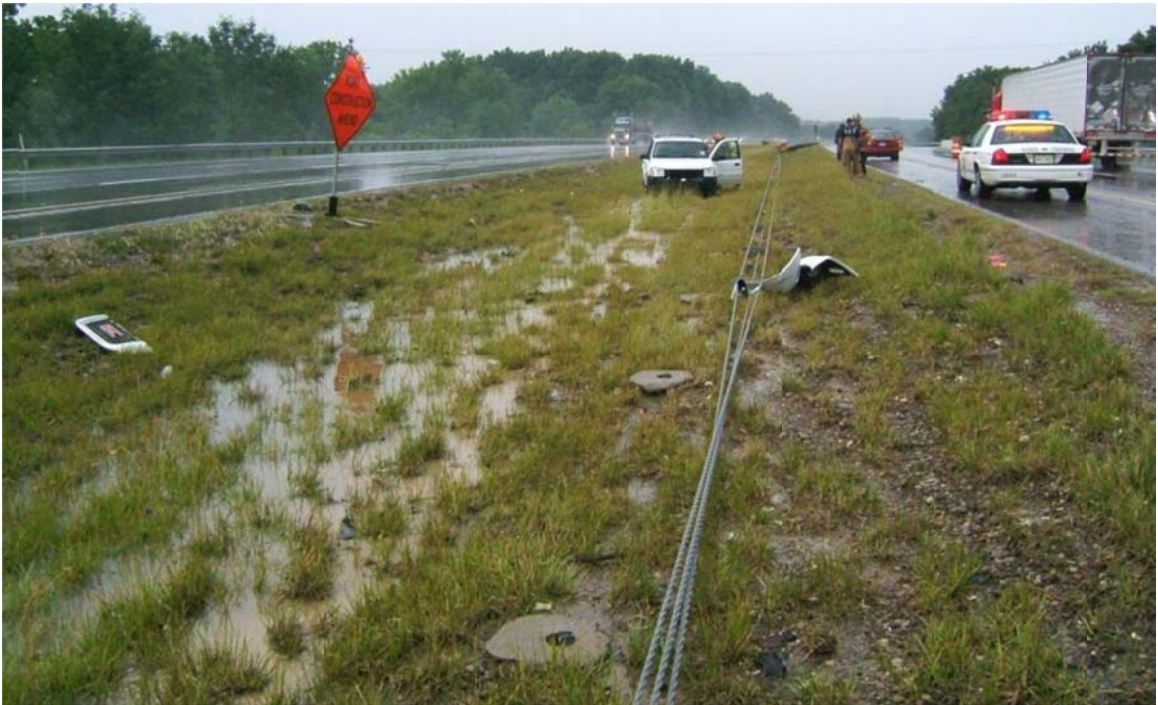
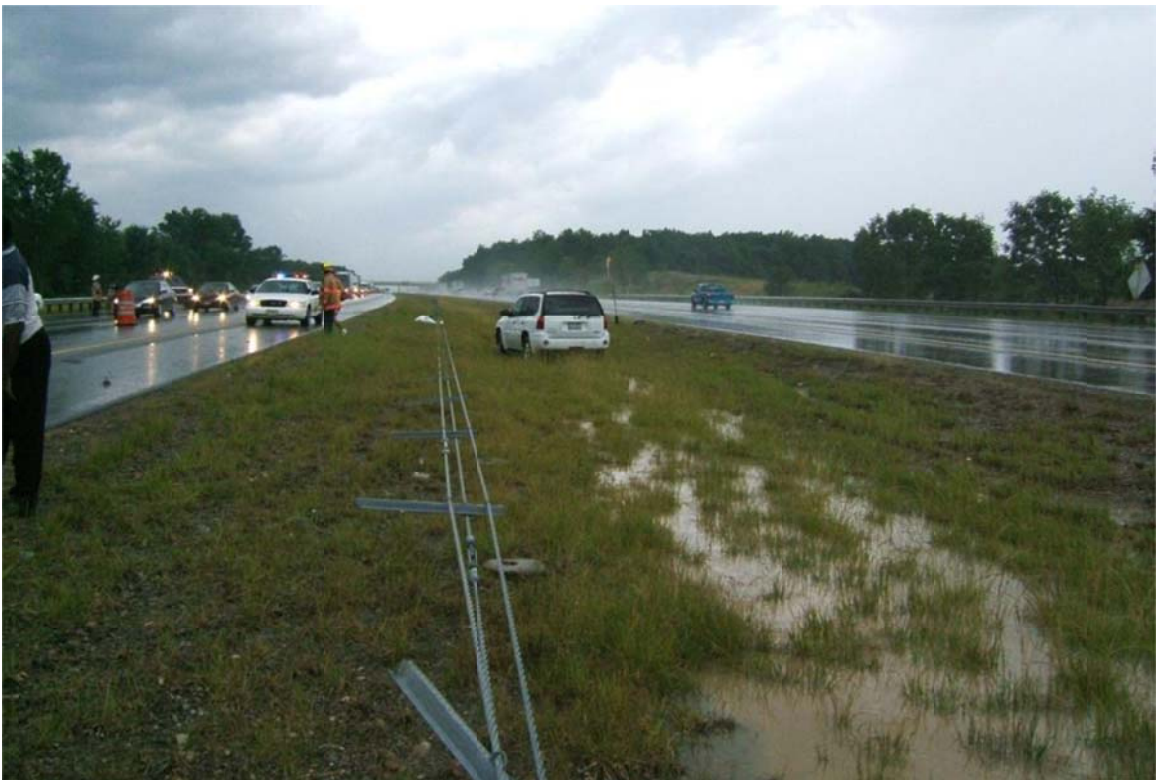
Figure 83. Override Penetration Crash Caused by Strong Cable-to-Post Attachment

The penetration event occurred due to a combination of the following three factors: (1) sequential impacts with posts in the system caused post fracture in the socketed foundations with virtually no plastic deformation of the post; (2) the cable-to-post attachments remained firmly attached to the cables, causing the fractured posts to accumulate in front of the vehicle, while downstream posts fractured and were displaced back with the impacting vehicle; and (3) a long, unsupported length of cable combined with the weight of displaced posts tended to pull the cable downward, causing separation of the bumper cover of the vehicle and marginalizing the "capture zone." In this reference, capture zone (CZ) refers to the front area of the vehicle between the upper bumper surface and the lower edge of the hood. This area frequently corresponds to a blunt surface concealing cavities in the vehicle made for headlights, the radiator, and the engine compartment. The CZ concept has frequently been invoked when discussing cable barrier placement in V-ditches and explaining both failures and successes of certain cable barrier systems, though a formal characterization has never been given to this region of the vehicle.

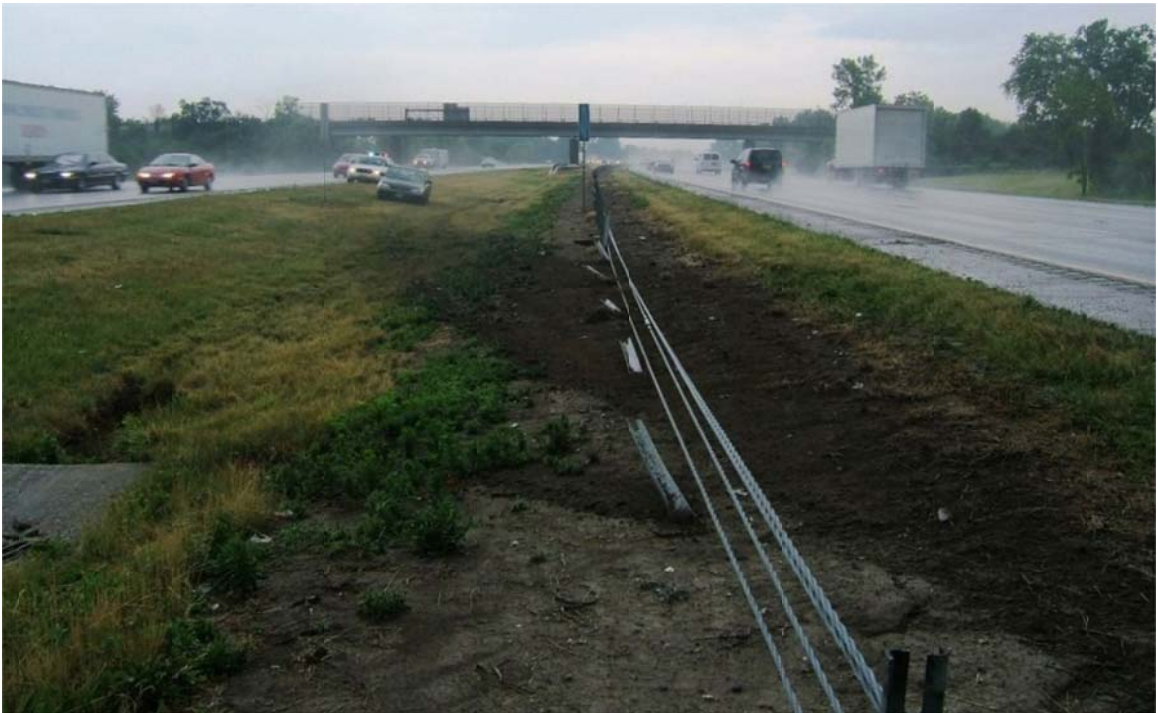
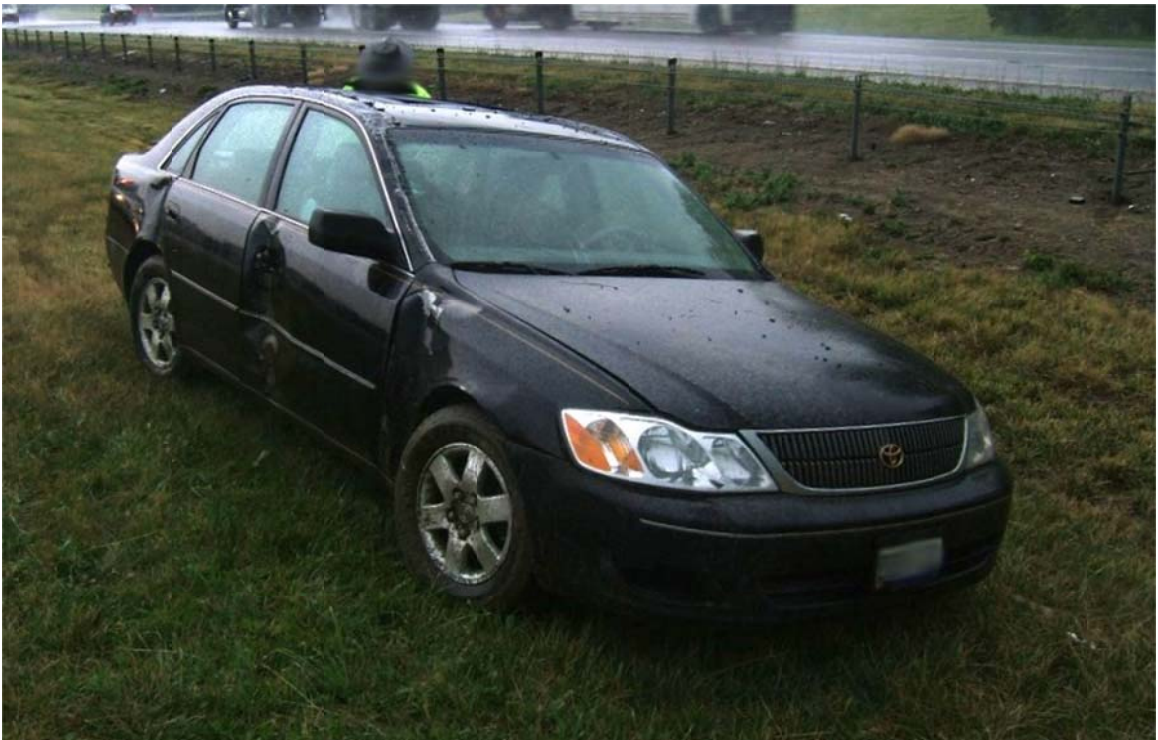
Figure 92. Prying Underride Failure on Brifen WRSF

Immediately after impact, the force of the redirection caused the vehicle to yaw with the right-rear corner turning into the barrier. These forces were eccentric to the vehicle's CG and thus were relatively low to cause yawing. As a result, the forces never exceeded the breaking strength of the front headlight glass casing and the cables did not crease into and engage the vehicle. As the vehicle's back end rotated into the barrier, the cables slipped over the front bumper and hood corner due to the prying force and the vehicle penetrated under the barrier. The sunroof was shattered due to contact with the cables.

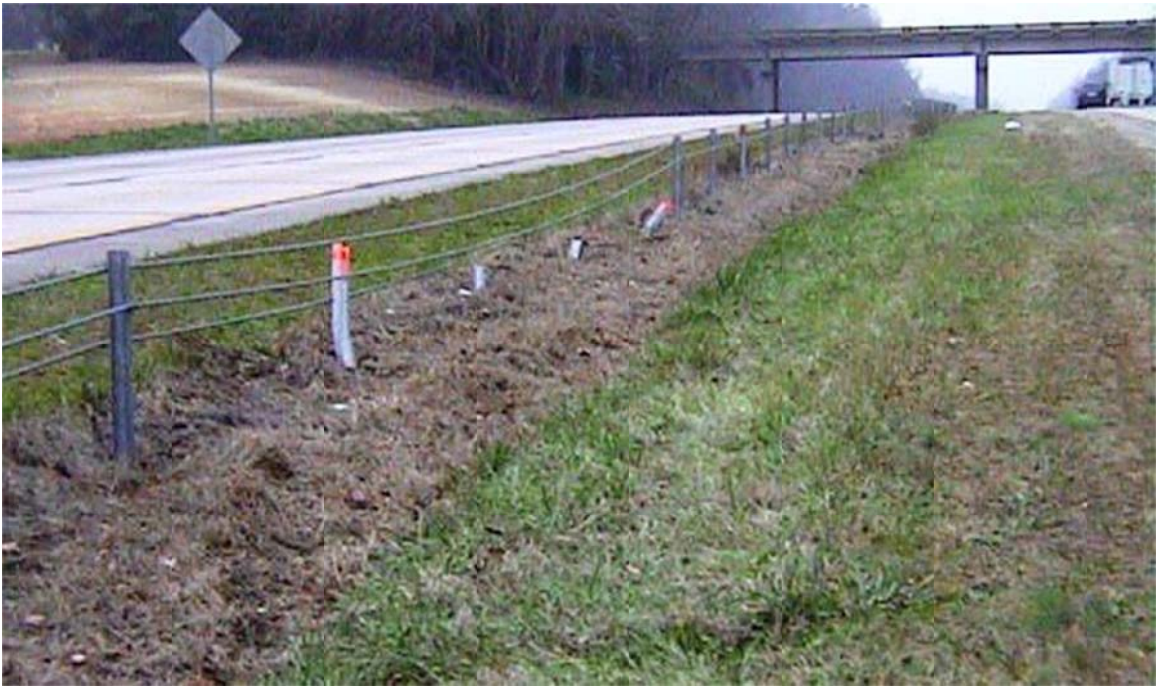
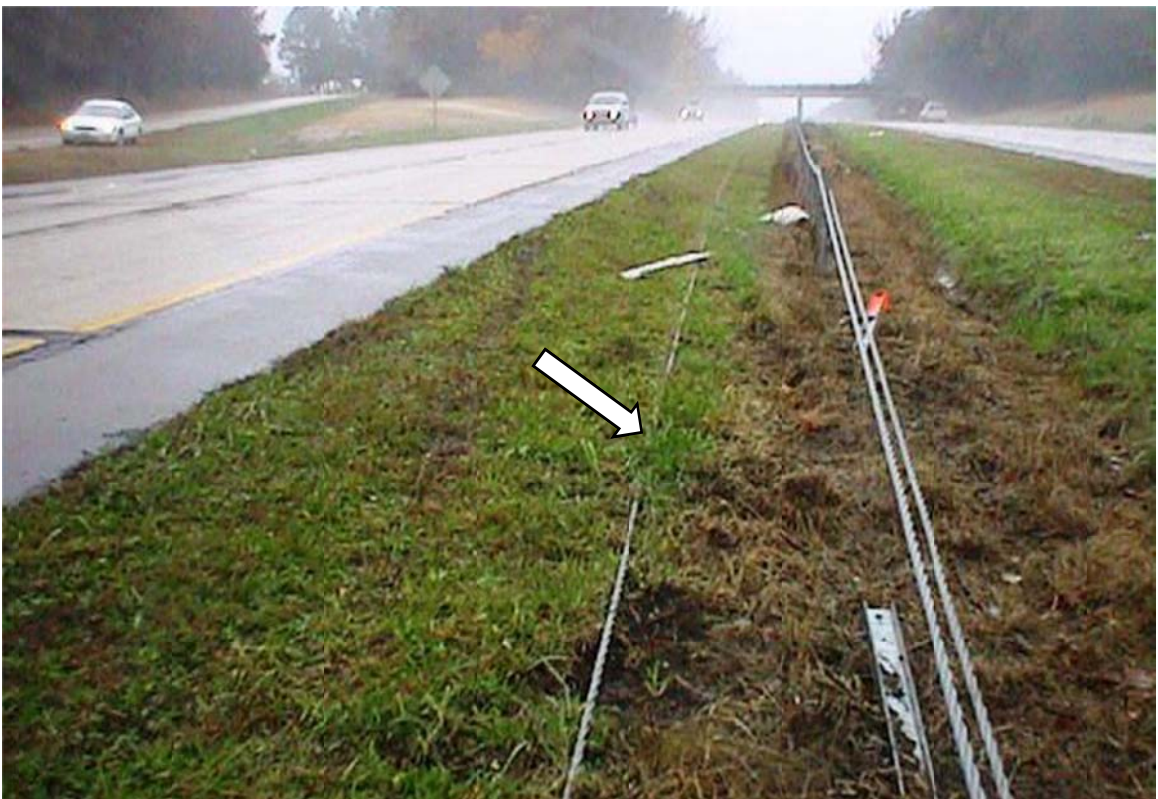
Figure 98. Back Side (Middle) Cable Release from Many Downstream Posts Resulting in Penetration

Prying penetration crashes typically occurred via a combination of the following factors: (1) cables located on the back side of the post released from many posts because lateral forces exceeded cable-to-post attachment strengths; (2) large orientation angles promoted bumper protrusion between or below the cables contributing to underride or through-cable penetration; and (3) low contact forces prevented beneficial body panel crushing or headlight fracture, causing poor cable-vehicle engagement. Back-side cable release most commonly occurred when other cables failed to adequately engage the vehicle, so the entire redirection load was applied by one back side cable. Examples of penetration crashes in which the impacted back-side cable was removed from more than 10 posts downstream from impact are shown in Figures 98 and 99.

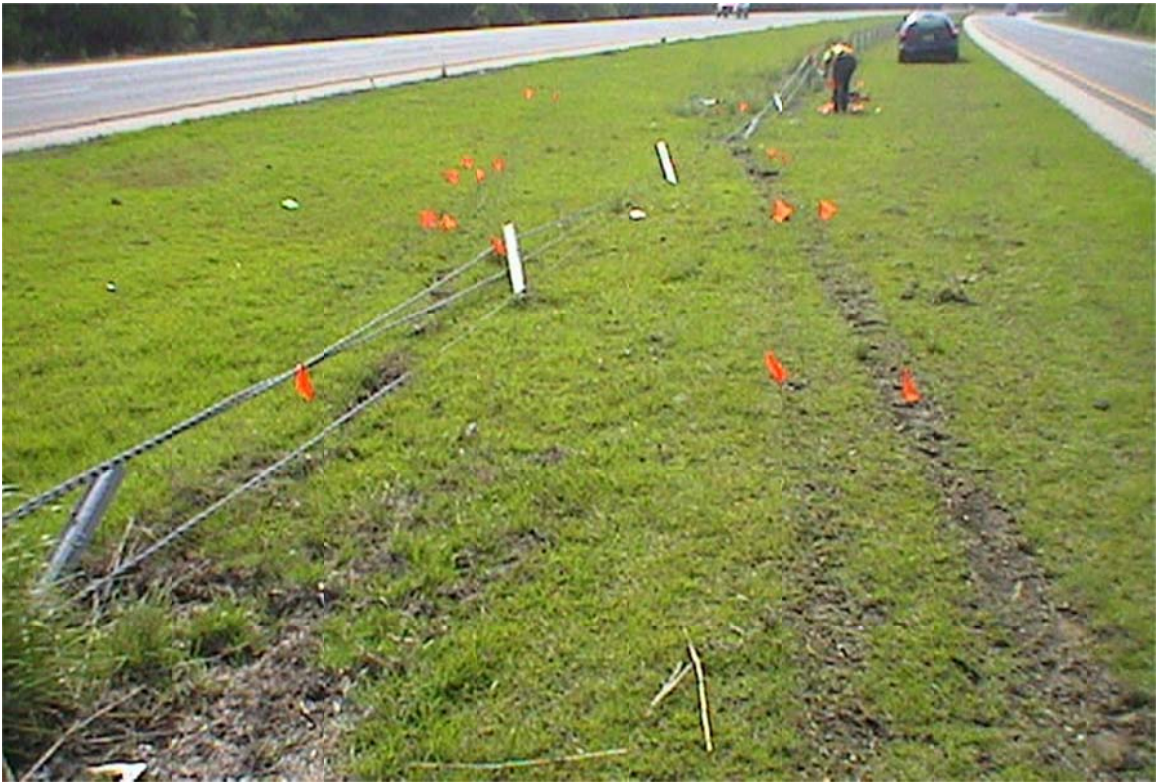
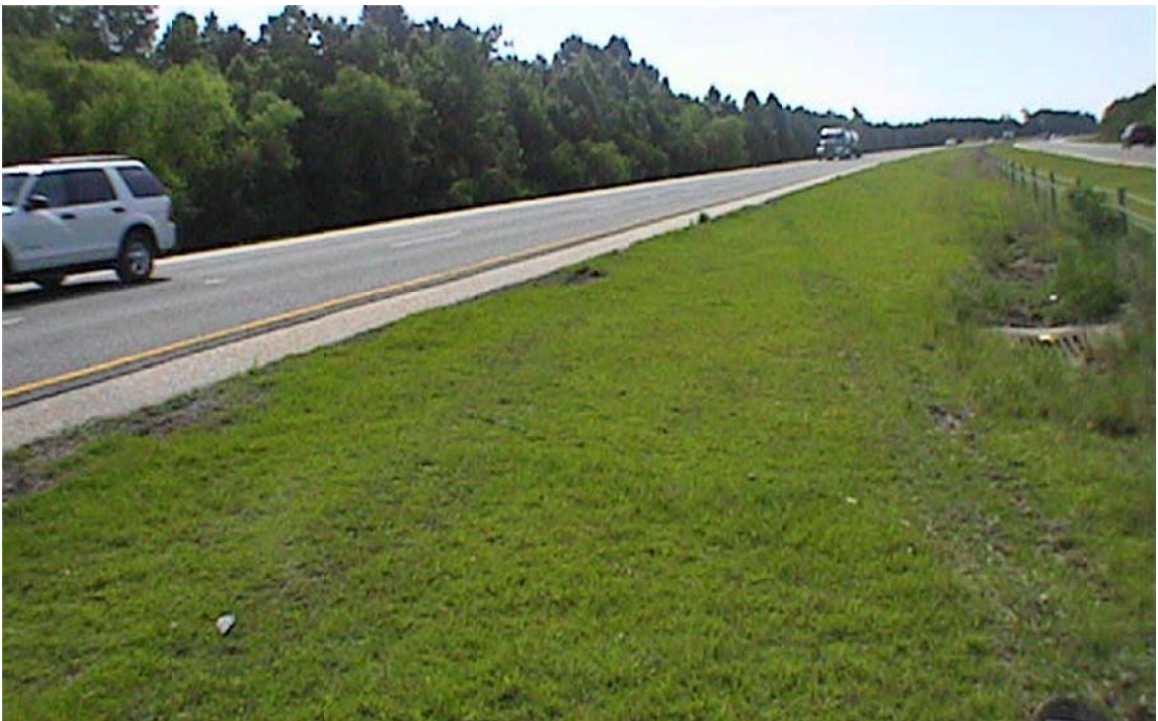
Figure 100. Prying Penetration Failure with SUV Caused by Brush Guard

Such an event was anomalous because very few impacting vehicles were equipped with these guards. However, the effect of the brush guard in this crash was a microcosmic representation of the effect of weak cable-to-post attachments on strong posts. Even large vehicles, which were typically excellent candidates for redirection on cable median barriers, were at increased risk of prying penetration crashes at high orientation angles. This further supports the conclusion that orientation angles can alter the energetically preferential interaction of vehicles with cable median barriers. If a sufficient contact groove was not made before the impacted cables began to slip on the vehicle, the likelihood of redirection was very low.

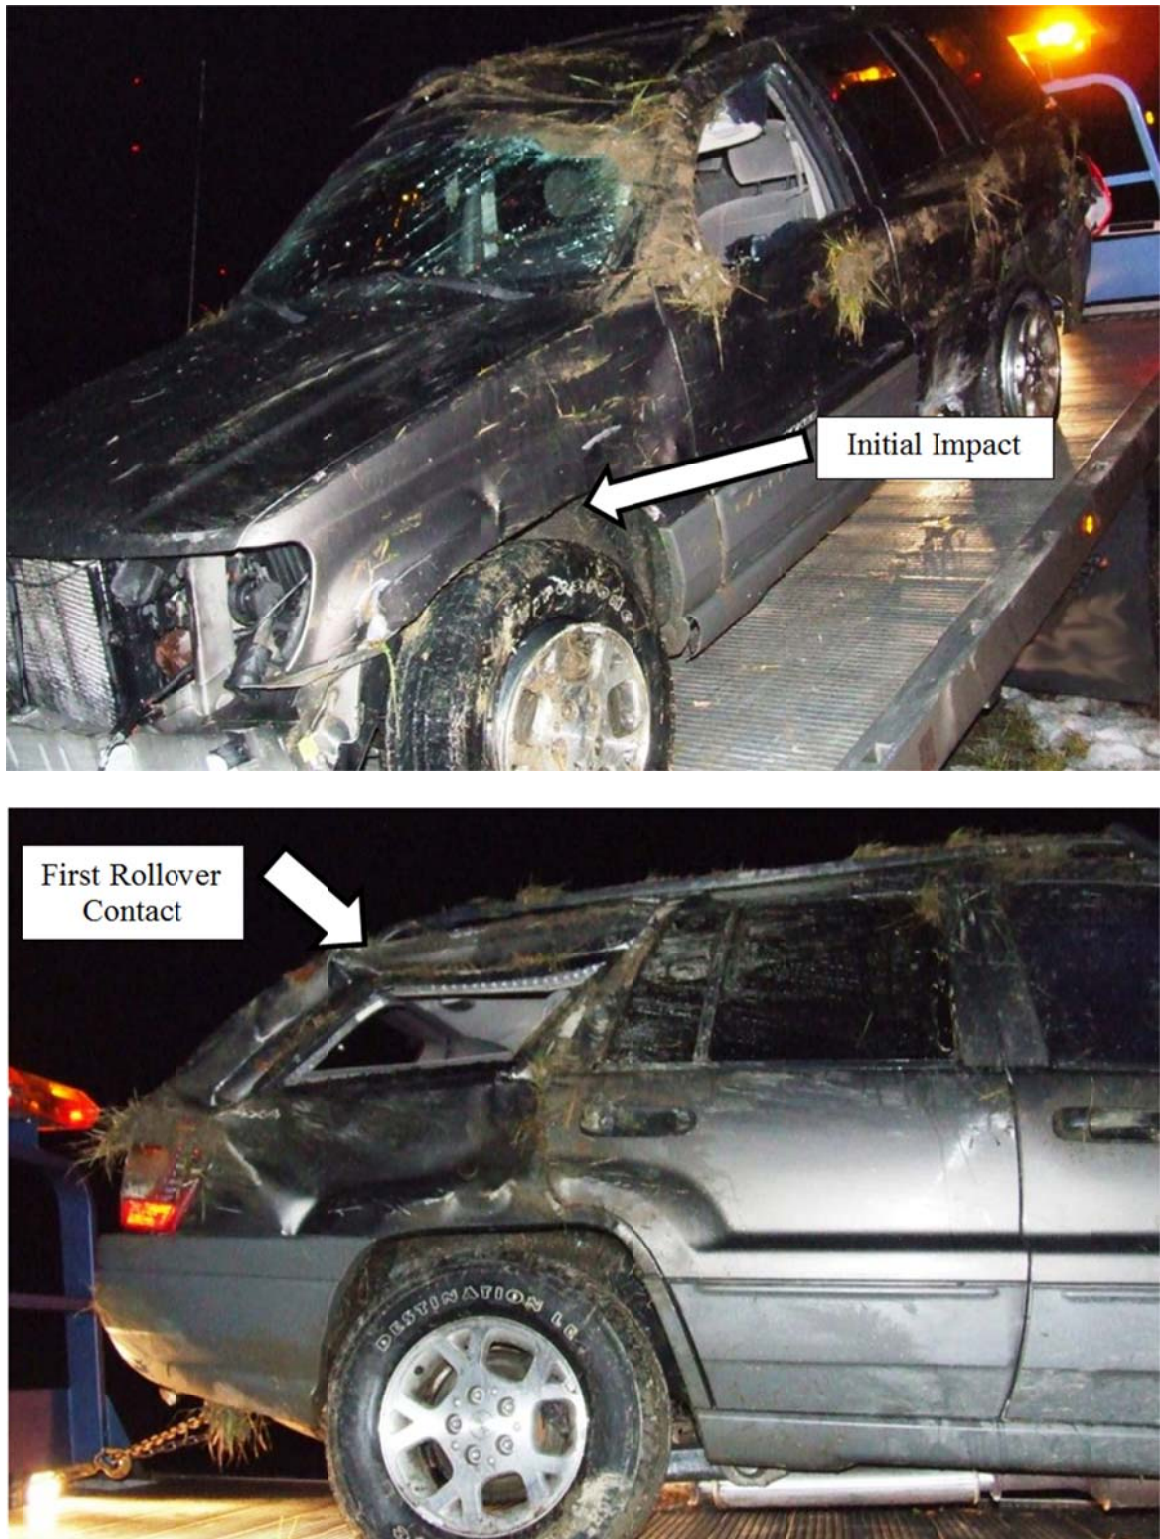
Figure 129. Example Rollover Crash Caused by High Orientation Angle at Impact

One crash involving a Jeep Grand Cherokee is shown in Figure 129. During this crash, the vehicle struck the cable barrier with the left-front corner in an oversteering configuration, yawed around the front end, and tripped as the vehicle approached a 90-degree orientation angle. The right-rear corner made first contact with the ground, shattering the rear windshield and right-rear window. As the vehicle rolled, the roof was crushed, but most of the remaining damage to the vehicle only occurred to the exterior body panels. A similar crash involving a Suzuki Grand Vitara which also yawed around the front end before tripping is shown in Figure 130.
